SOHO

Update on the wheel speed anomaly

Ref: SOHO/PRG/TN/549, issue 1.0, 2002.FEB.25

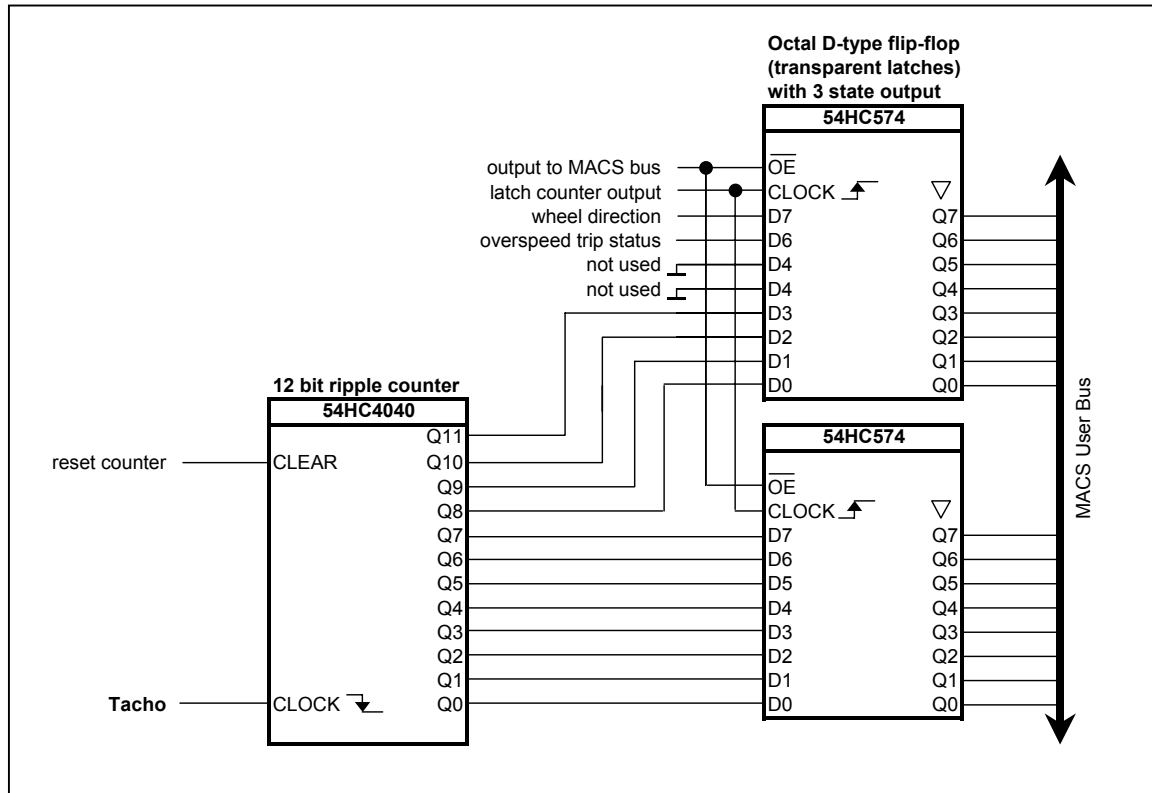
Wheel tacho counter circuit diagram

The reaction wheels generate 240 tacho pulses per revolution. These tacho pulses are counted by an HC4040 12-bit ripple counter. Every 46.875ms, the counter outputs are latched in 2 HC574 8-bit transparent latches, along with the wheel spin direction and the over-speed trip status, then the counter is reset.

The 46.875 timing window is synchronized on the MACS bus. It is obtained by counting 384 MACS sync pulses. There is 1 sync pulse every 25 MACS clock pulses and the MACS clock frequency is 204.8kHz $\rightarrow 384 * 25 / 204800\text{Hz} = 0.046875\text{s}$.

The raw wheel speed is directly the number of tacho pulses counted within the 46.875ms window. This results in an lsb of $60 / (240 * 0.046875) = 5.3333... \text{rpm}$

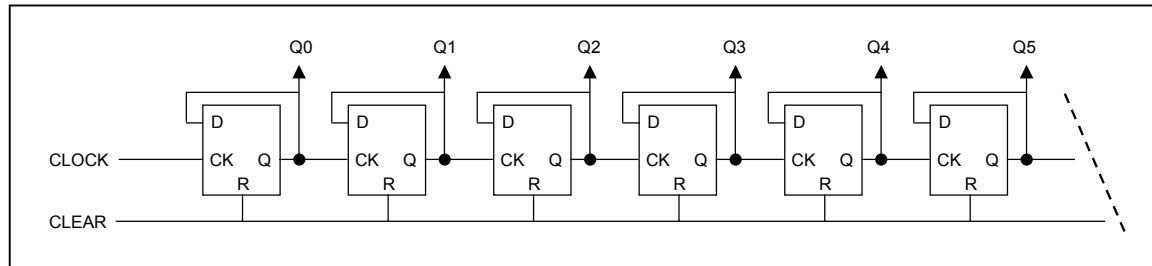
HC4040 counter logic diagram

Looking at the break-down of the faulty binary patterns, the true nature and the origin of the anomaly becomes obvious: the counter output is latched while carries have not finished propagating through the counter stages. Indeed, the HC4040 is a *ripple* counter. Unlike a synchronous counter (ex: HC193), the outputs do not change synchronously with the clock, the counting propagates through the 12 stages of the counter, with a certain delay, from one stage to the next.

The HC4040 datasheet specifies that the propagation delay, from one counter stage to the next (Q_n to Q_{n+1}), is between 5 and 15ns, depending on supply voltage and temperature. Consequently, if the current count ends with consecutive “1” bits, the next increment will result in the propagation of a carry through several stages of the counter. Until the propagation is over, the counter outputs are incorrect. The following figure illustrates this.

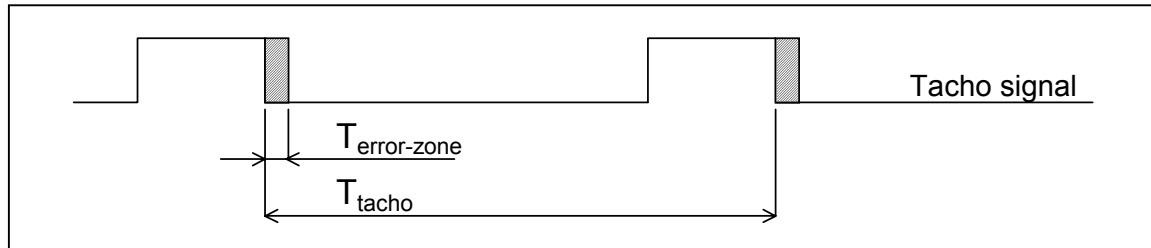
This anomaly is not purely probabilistic. In theory, an error can occur at every acquisition if the wheel speed and the 46.875ms window phasing are, and remain, just right. In practice, however, this is quasi impossible and it seems reasonable to consider that the tacho pulses and the 46.875ms timing window are not correlated. The probability of an error is then the ratio of the propagation error zone to the tacho period.

probability of error : $P_{\text{error}} = \frac{T_{\text{error-zone}}}{T_{\text{tacho}}}$ with $T_{\text{tacho}} = \frac{60}{240 * \text{RPM}}$
